CASE STUDY

CorkSol is proven as leading Thin Internal Wall Insulation solution

New SprayCork reduces heat loss through walls by more than 30%

Date Nov 2020

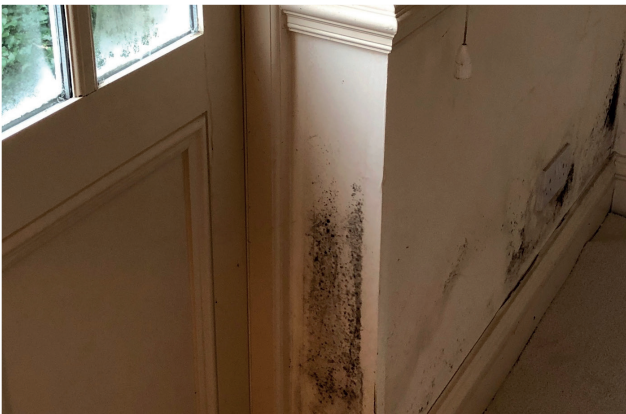
Mould and condensation problems around window reveals and corners

The small gas boiler struggled to keep the property warm in winter and there was mould and damp evident on the walls, primarily in the corners and around the reveals of the French doors and windows. By drilling into the walls we confirmed that there was no existing insulation, just plasterboard dot and dab fixed direct to the 300mm thick stone. The large dabs holding the plasterboard in place were cold to the touch, and the IR camera confirmed clearly that they were acting as a strong cold bridge.

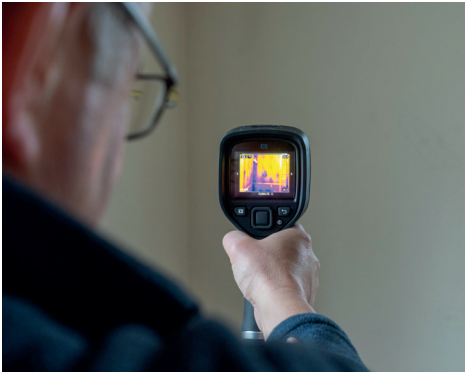
Infra Red imaging before treatment

now fully dry, it made for a great test wall. We determined the exact mounting point for the test rig using IR camera images to avoid those cold bridge dabs which might skew the test.

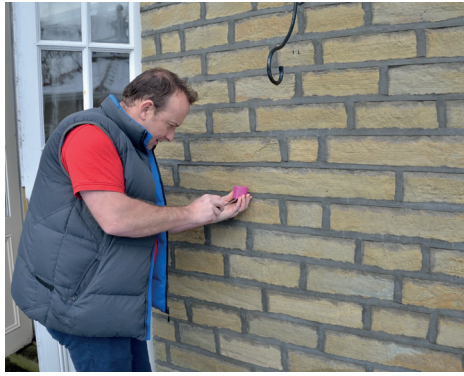
Exterior set-up of U-value testing sensor

The U-value test kit used, an ISO 9869-1:2014 approved Swiss system, requires three measurements - internal

temperature, external temperature and heat flux - to be recorded every minute for at least 72 hours. The test requires internal and external temperatures to be significantly different, so the fact that we were running the test in winter and had control over the central heating system helped.

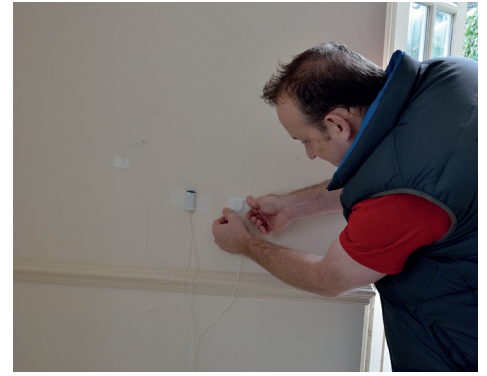
Pre-treatment set-up of U-value testing sensor

The wall was tested before application of SprayCork, and a U-value of 1.58W/m2K was obtained. This is a reasonably good performance for an uninsulated stone wall, but well within the expected range.

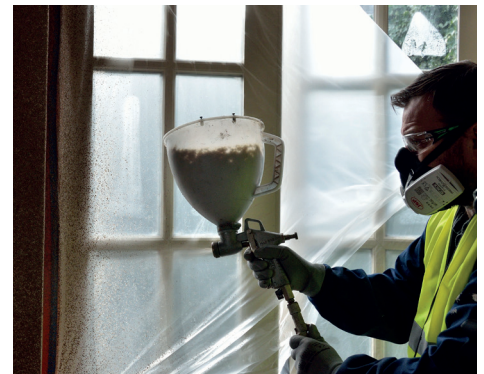
Continuous, seamless application

SprayCork was spray applied seamlessly direct to the existing plasterboard, across the whole internal surface of the exterior walls and around the window reveals. Application was in two layers giving an overall depth of 5-6mm. After drying, the walls were skimmed with 2mm of standard gypsum plaster, all in the same day.

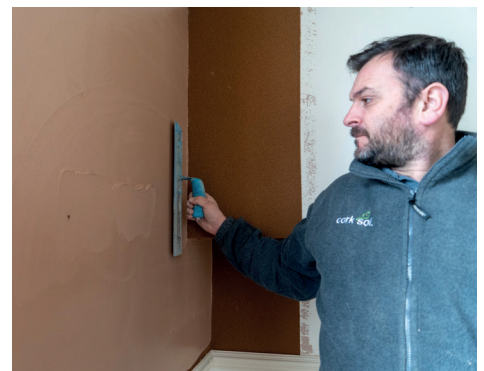
Plaster skim directly over the SprayCork

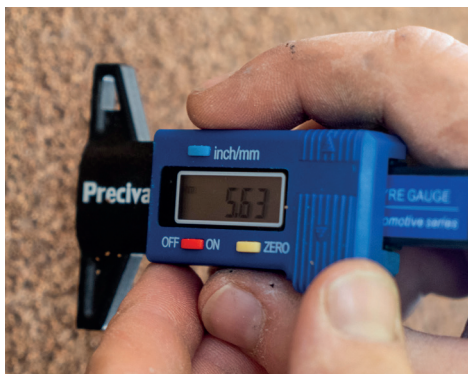
Thin layer solution
